Manhole Inspection Summary

Manhole # S19G__009MH

Insp Date: **9/20/07 7:31 AM**

Location Address: **13 PAYSON ST**

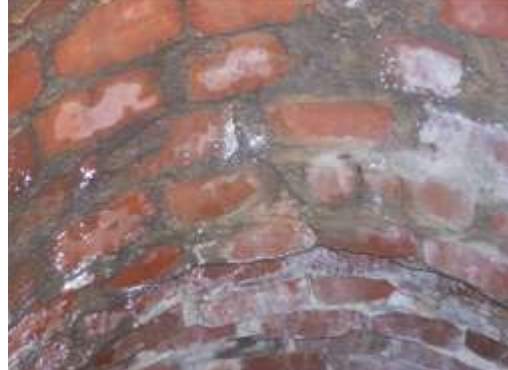
Defect 2

Condition: ☐ Sound ☒ **Cracked** ☐ Root Intrusion ☐ Loose Brick ☐ Deteriorated

CRACKED CORBEL

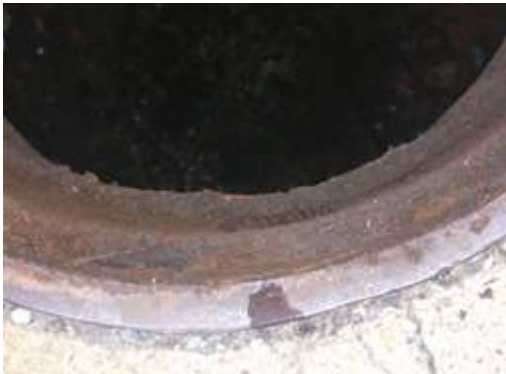
Defect 1

Offset: **1** (in.)

FRAME OFFSET

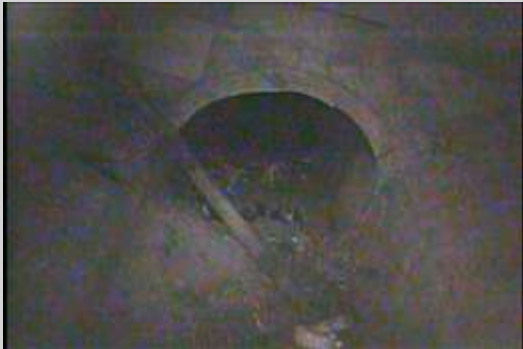
12 O'Clock Outflow

8 in. Circular Gravity Sewer
Pipe Out @ 12 O'Clock

Deposits: ☐ None ☐ Mud ☐ Sludge ☒ **Debris** ☐ Grease

Silt Depth: **2** (in.) Deposits Extent: **Light**
